FINAL REPORT FOR STA-2A NDT TESTING

MORTON THIOKOL, INC.

FINAL REPORT ON STA-2A NDT TESTING

25 NOVEMBER 1987

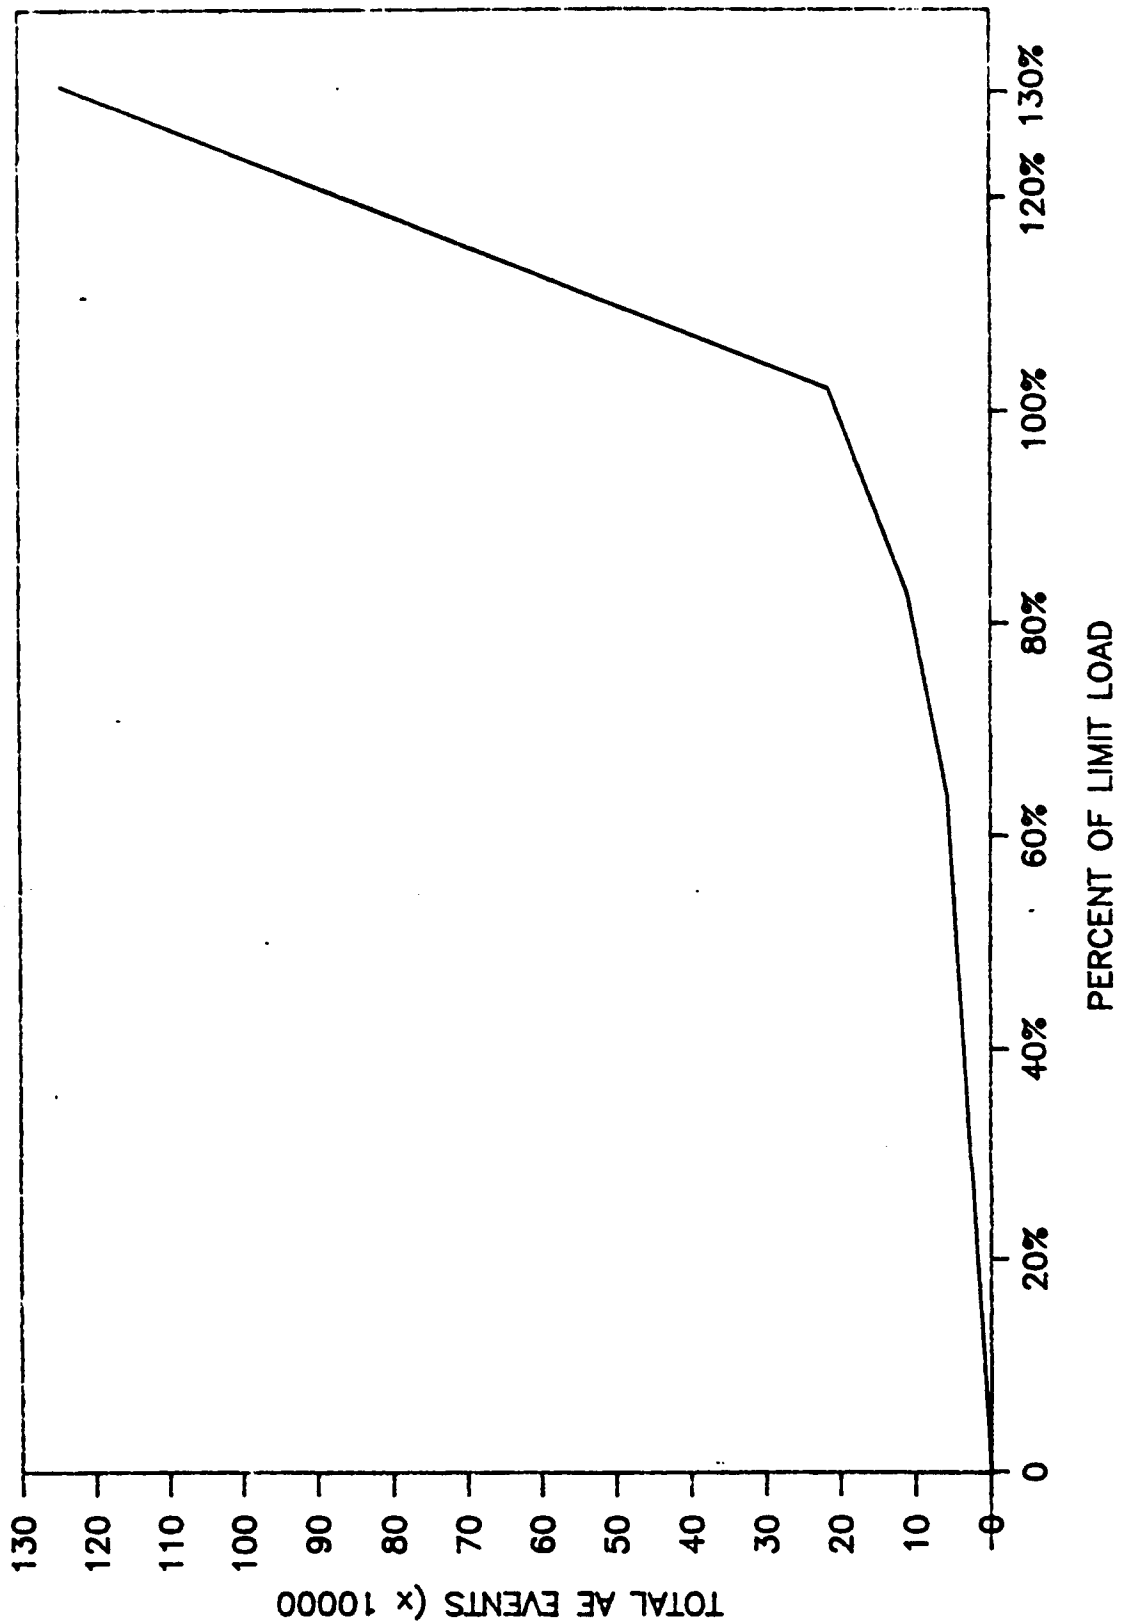
**FIGURE 26. STA-2 PHASE 7B
CUMULATIVE EVENTS VS. LOAD CYCLE**

Figures 23 and 24. The AE events versus load curve is shown in Figures 25 and 26. Figure 26 shows a non-linear increase in events after 100 percent load. The early event activity came from the previously mentioned sensor locations. This gave a felicity ratio of 0.91. This data indicates damage was near sensor locations 54, 60 and 71. The relief valve noise masked emissions during download of pressure.

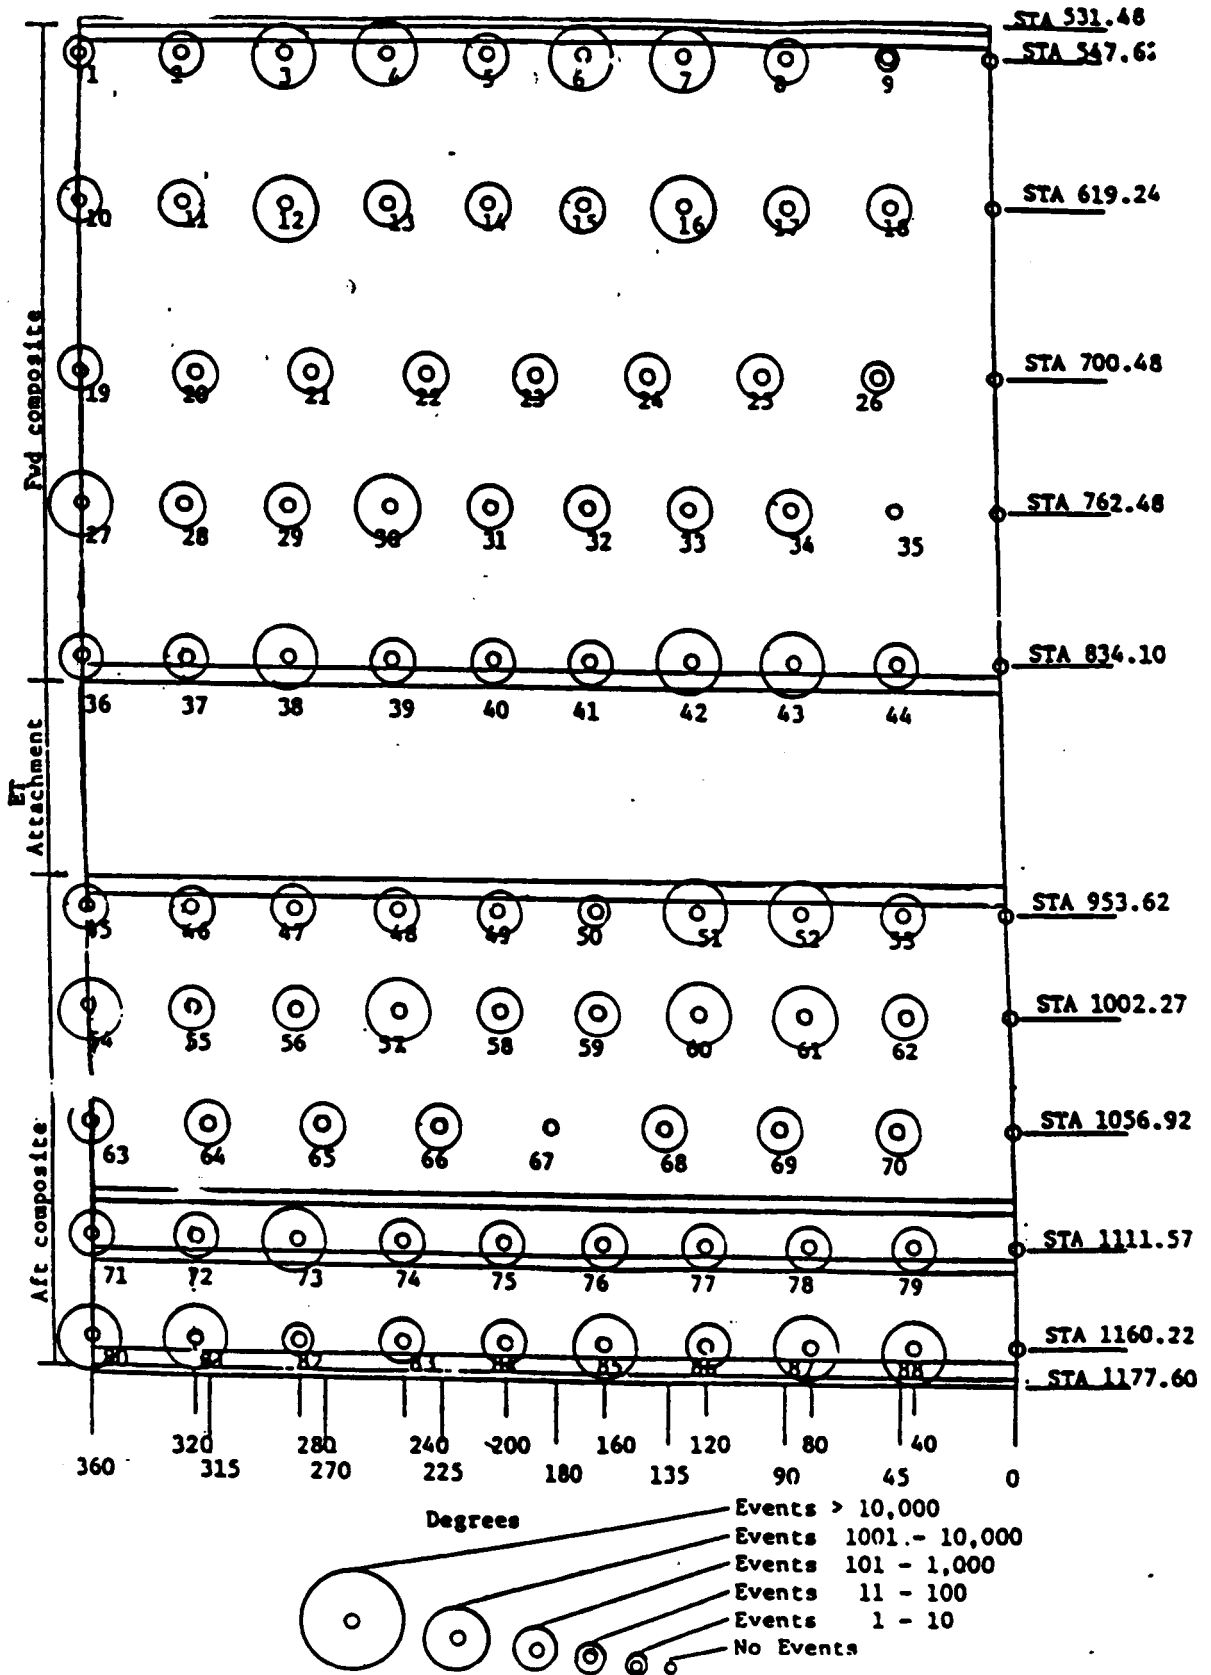
FIGURE 33. TOTAL EVENTS PER SENSOR LOCATION
TEST PHASE 8

The AE data shows no significant defect growth during this test phase. Figure 33 shows the total number of events recorded at each sensor location. AE activity was evenly distributed throughout the case. The AE activity increased when the load exceeded 750 psi. This gives a felicity ratio of 1.05. All sensors had good event roll-off during the load hold. No long duration events occurred. A post test Pulse Echo and visual inspection found no new damage.

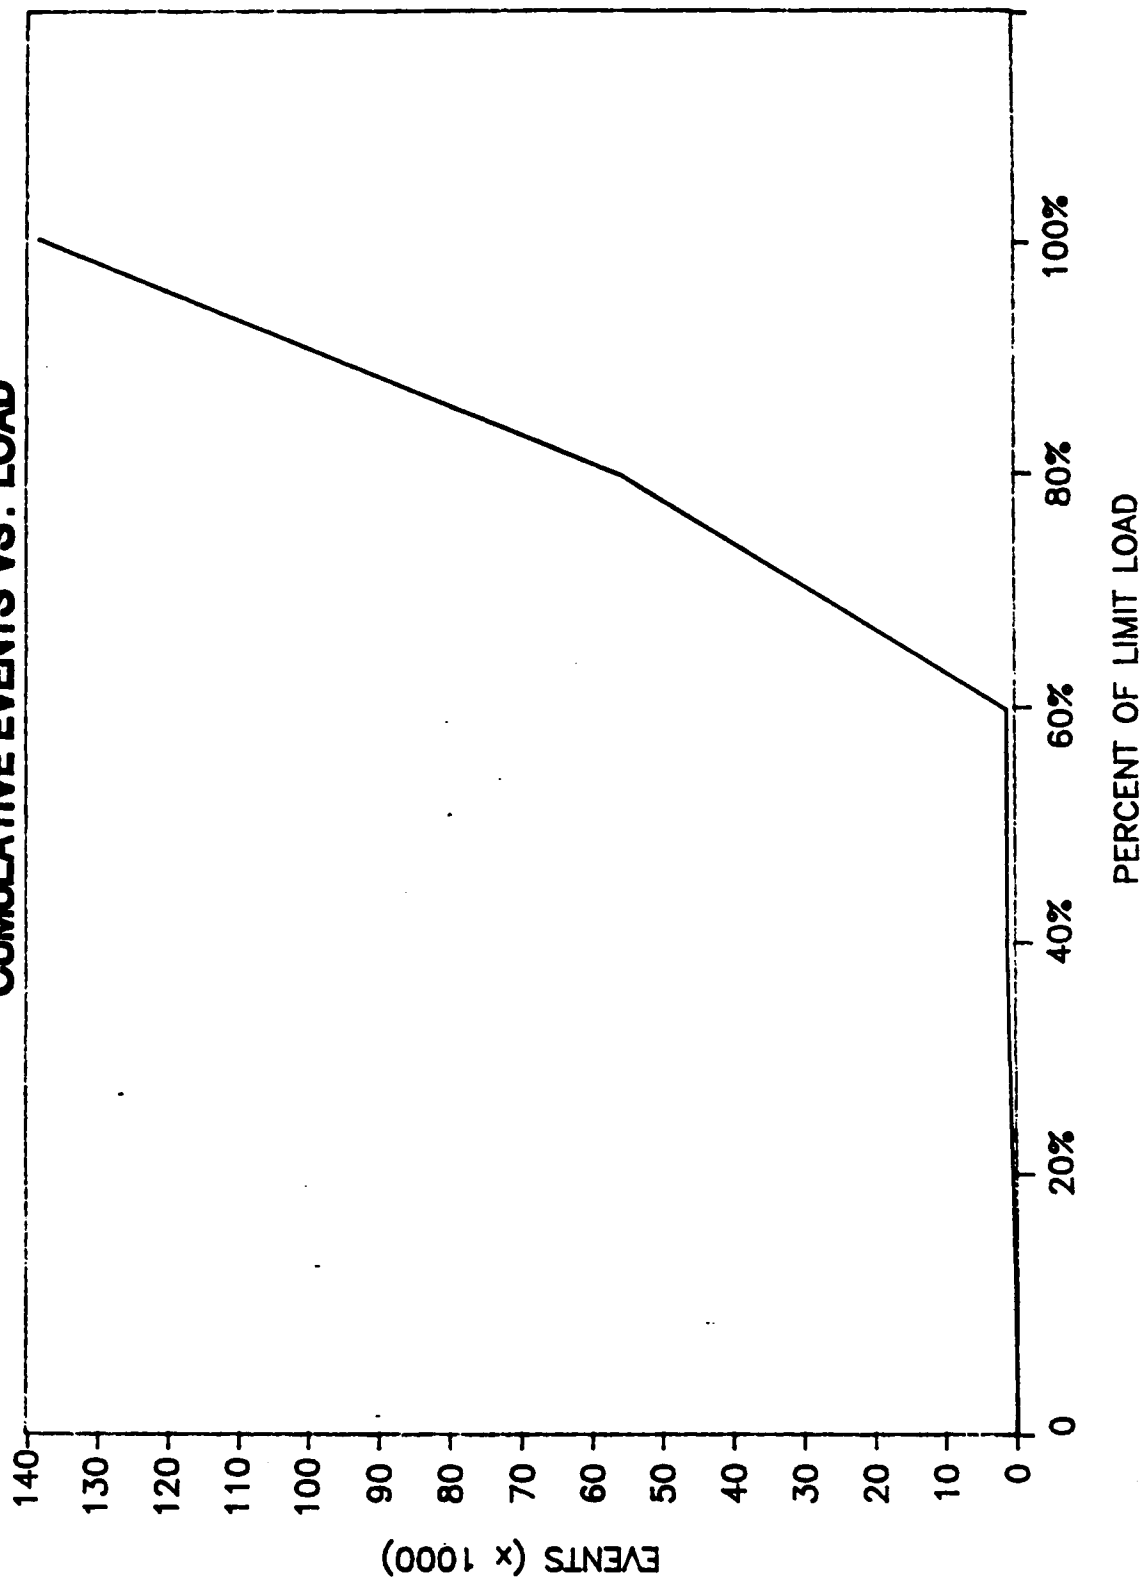
FIGURE 40. STA-2 PHASE 9C-2ND LOADING

The second loading of STA-2A occurred 17 May, 1985. The test was stopped due to high AE activity and unusual deflections in the case. The applied loads are shown in Figure 35. The real time AE data shows significant defect growth occurring in the Aft Segment, Aft Transition region near 160 degrees. Figure 40 shows the AE events versus load. A non-linear increase in AE events occurred when the load increased from 60 to 80 percent. During the 80 and 90 percent load hold the emissions continued to increase for the duration of the hold. During the reduction of load, friction type emissions occurred in the Aft Transition region. Figure 41 shows the total event range during load hold of each sensor location. Sensors 71, 84, and 85 were the predominant regions.

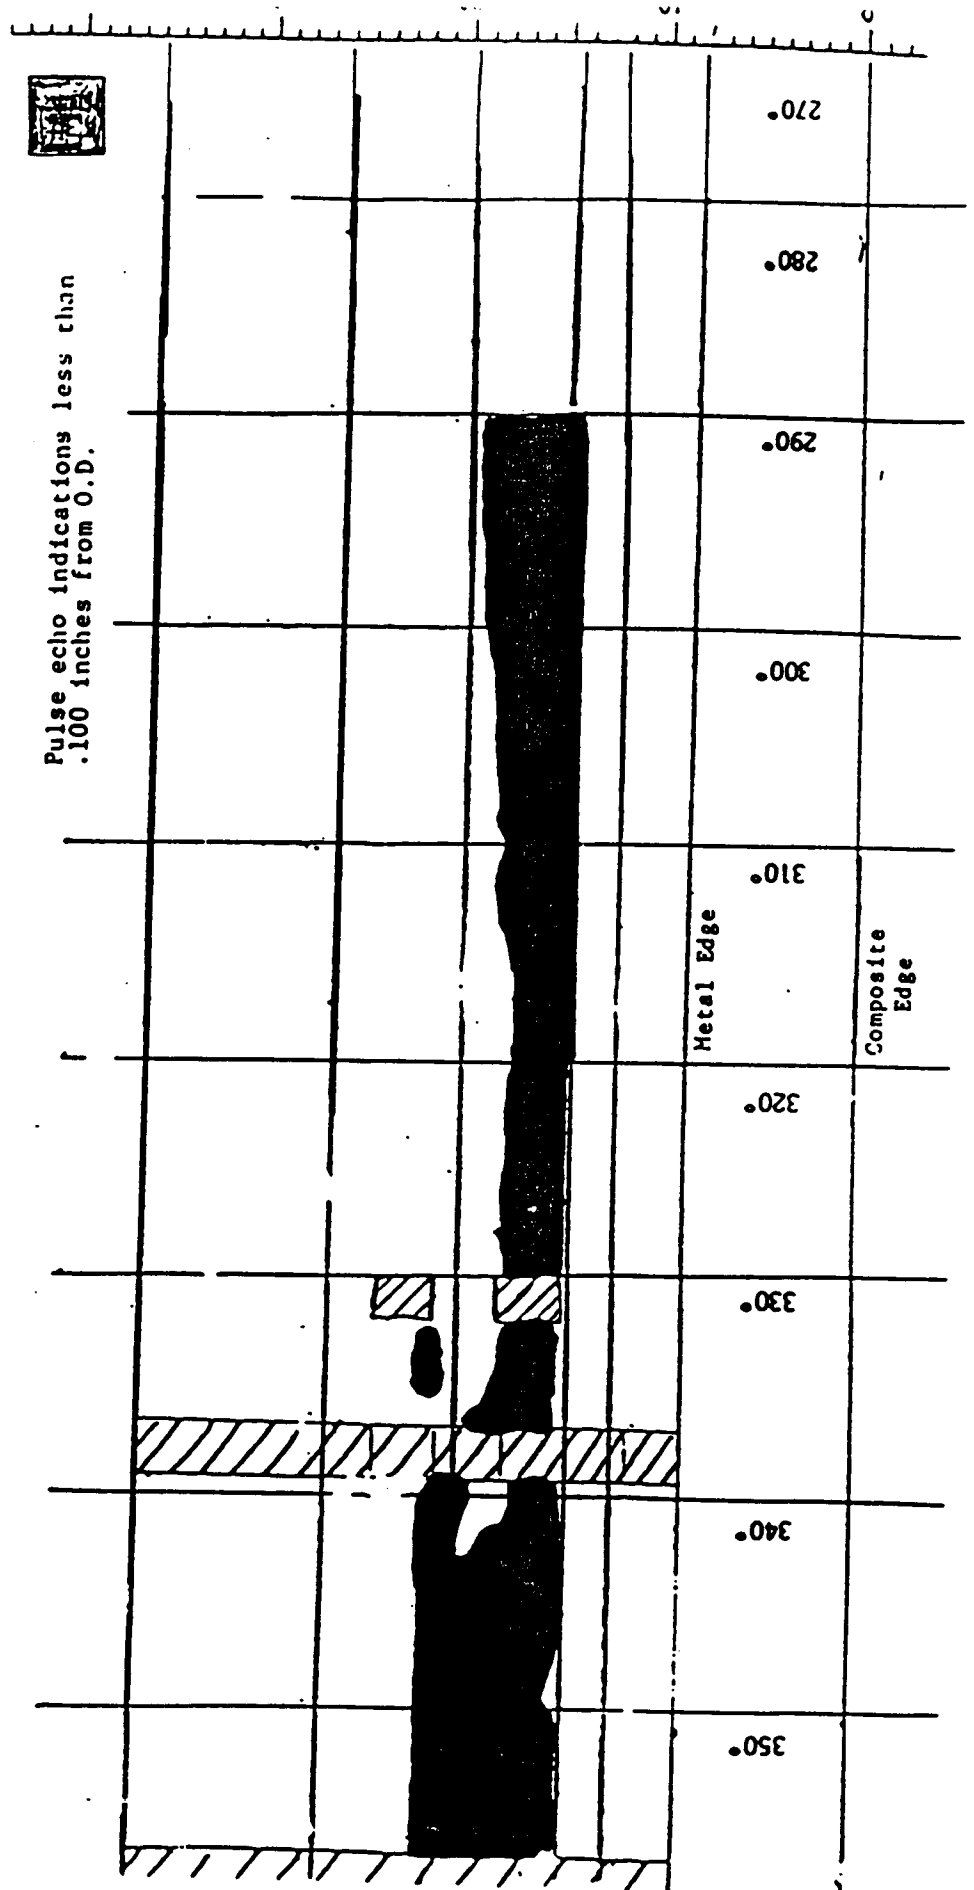
FIGURE 42. PULSE ECHO INSPECTION RESULTS

The AE data dictated the need for a follow up Pulse Echo inspection. The results of the inspection are shown in Figures 42 to 46. The Pulse Echo inspection was difficult due to the number of strain gages and wires attached to the case in this region. The Pulse Echo indications at less than .100 inches from the O.D. are

Pulse echo indications less than
.100 inches from O.D.

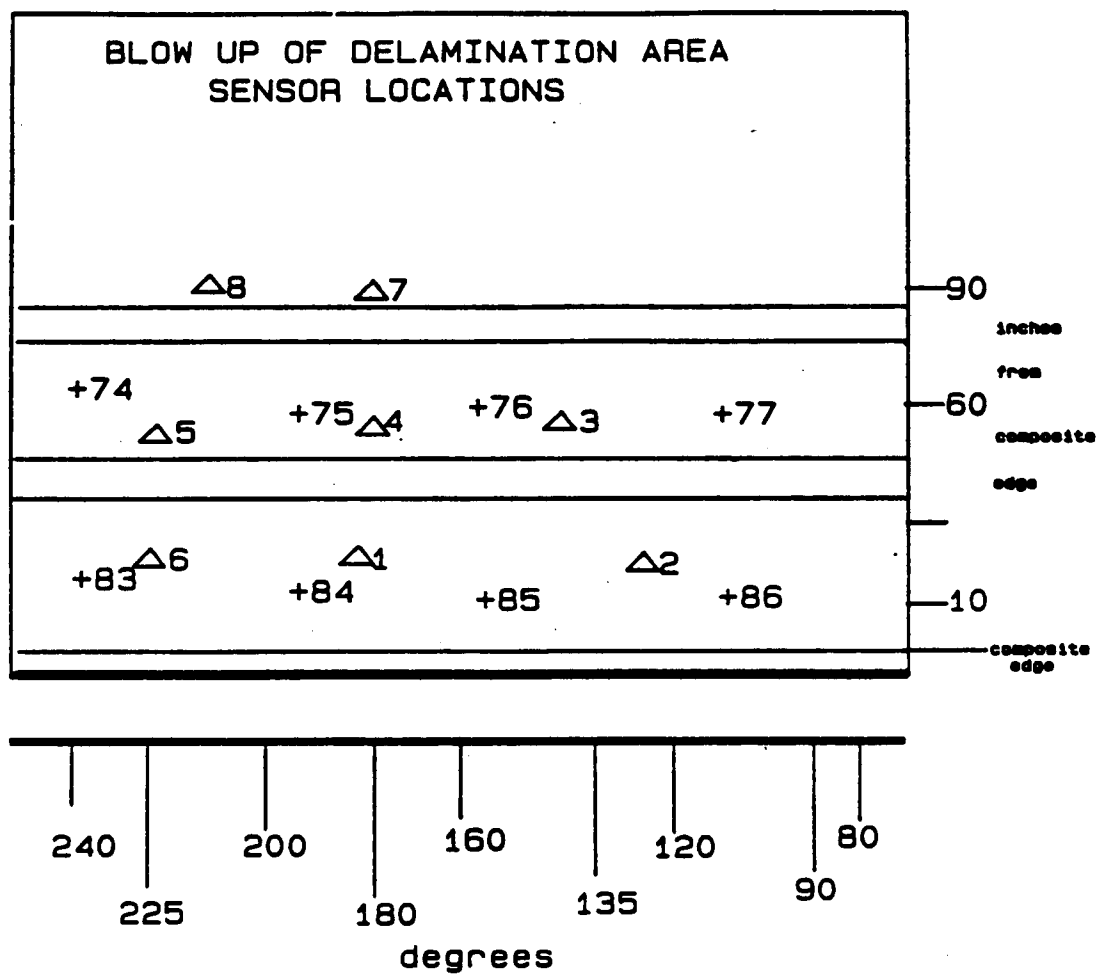
FIGURE 49 AE SENSOR LOCATIONS IN DEFECT REGION

Completion of the third pre-launch ultimate stress test (sixth load) was on 24 July, 1985. AE sensor locations were changed to closely monitor the delamination growth. Figure 49 shows the new sensor locations. AE activity began to increase at the start of loading (Figure 50). From 0 to 100 percent limit load the AE data originated from the known delamination. As the load increased above 100 percent the AE activity shifted to the outside boundaries of the defect. During the loading above 115 percent limit load the AE data shows that the defect grew in the forward direction until failure. Figure 51 shows the total number of events recorded at each sensor location in the defect region. The most active areas were near sensor locations 76, 85, 86 and sensors 2, 3, and 6. Cumulative results of all Pulse Echo inspection of all AE active areas are shown in Figure 52. The Pulse Echo data confirms that delamination growth occurred in the directions AE displayed in real time. Failure occurred in the location of unusually high AE activity noted during the first loading to 90 percent limit load. The AE data showing first hit and time of flight

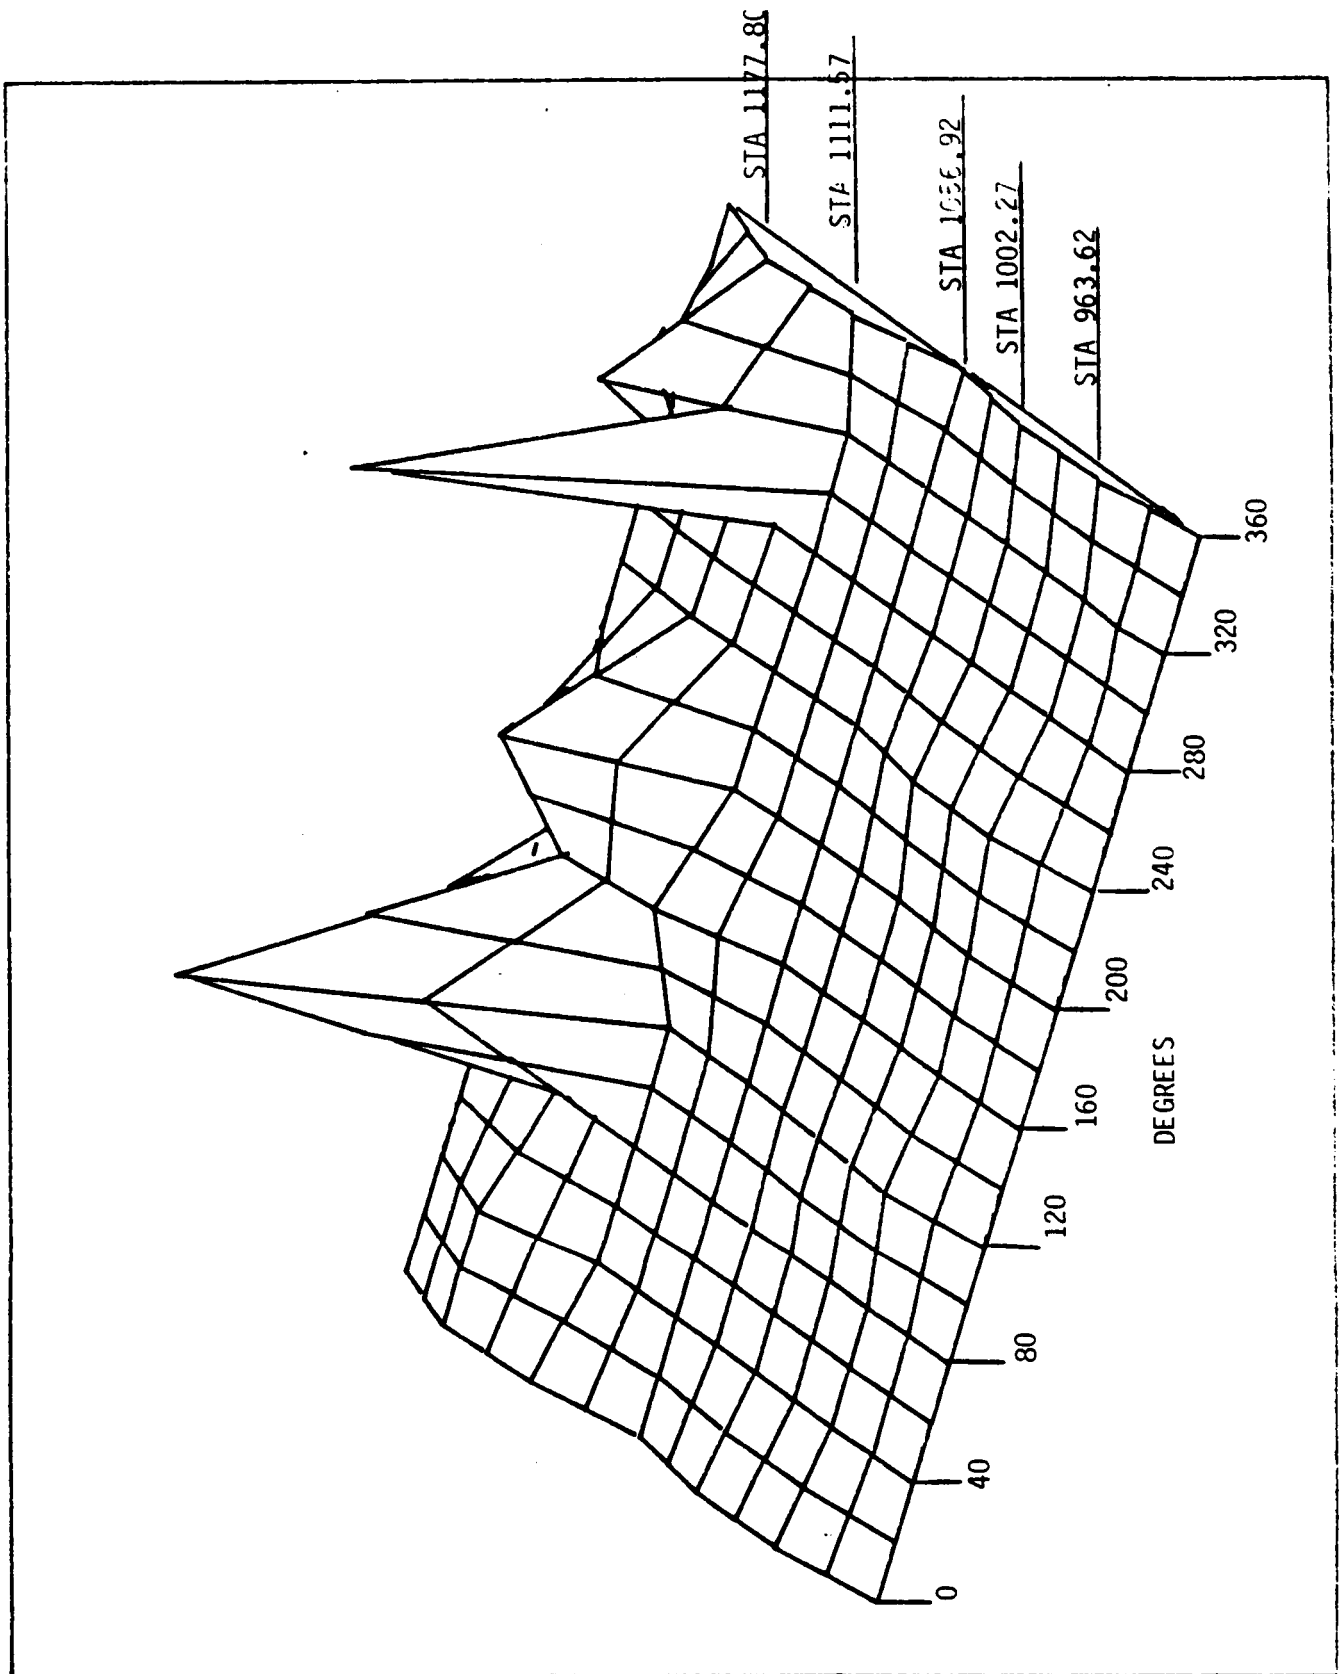
FIGURE 54. FAILURE LOCATION

measurements recorded, indicate the failure occurred in the location shown in Figure 53. Figure 54 shows a topographical map of AE activity for the Aft Segment during failure load.

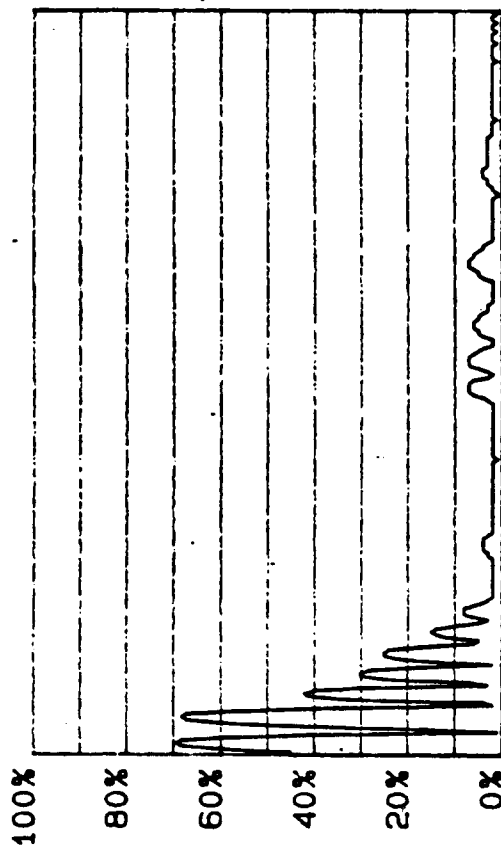
PART NO. STA-2A
 S/N Sample #9
 TECHNICIAN _____
 TEST REQ Full-Wave
 TEST LOCATION Area A

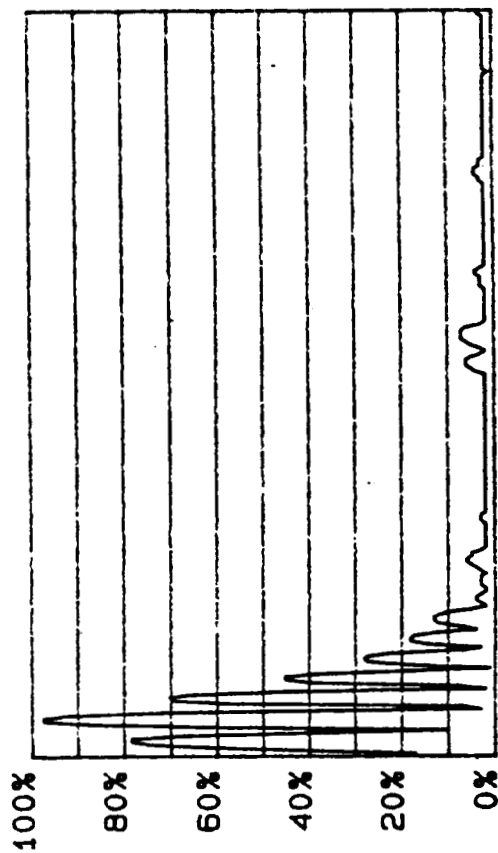
The location and dimensions of sample 12 are shown in Figure 59. This sample has two abnormal regions. Area A is plastilock with high porosity, area B is a delamination. Figure 60 shows the plastilock porosity at 28 inches to 30.5 inches with a mechanical measured depth of 0.080 inches. The delamination of area B had a mechanical measured depth of 0.230-0.245 inchs. The Pulse Echo depth was 0.260 inchs. The ultrasonic signal shown in Figure 61 displays that the near surface porosity blocks indications for backwall signals.

PART NO. STA-2A
 S/N Sample #12
 TECHNICIAN
 TEST REQ Full Wave
 TEST LOCATION Area B

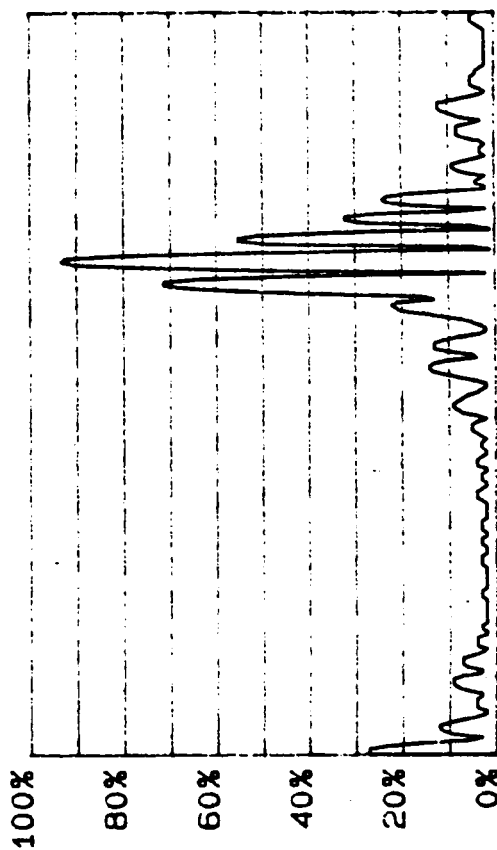
FIGURE 64.

Test sample 17 represents the forward edge boundary condition for the failure location. The forward boundary and depth information are critical for stress analysis and modeling. Figure 62 shows the sample dimensions and location of defects. Two defects are seen in this sample; Area A which is the forward boundary of the major delamination and area C which is an unbond of the Stiffener Ring build up region from the case. The Pulse Echo inspection at MSFC shows delamination growth of area A to be approximately 2 inches forward of the Stiffener Rib. Figure 63 shows a picture of this delamination. The Pulse Echo depth measurements of these flaws at MSFC gave an indication of 1.300 inches at point A and 0.530 to 0.547 inches at point B from the OD. The measured mechanical depths from the OD are 1.480 inches for point A and 0.600 inch for point B. The full wave Pulse Echo signal for location A and B are shown in Figures 64-65.

PART NO. STA-2A
 S/N Sample #17
 TECHNICIAN
 TEST REQ Full-Wave
 TEST LOCATION A

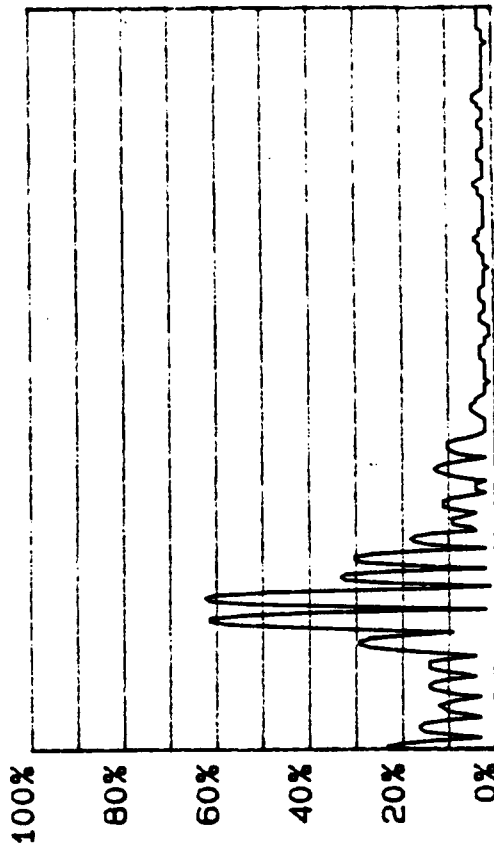
FIGURE 65.

PART NO. STA-2A
 S/N Sample 17
 TECHNICIAN
 TEST REQ Full-Wave
 TEST LOCATION B

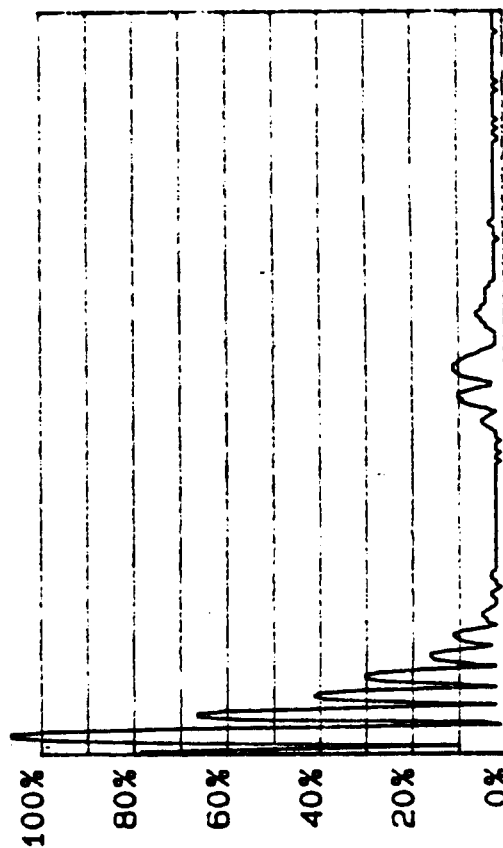
FIGURE 66.

Area C is representative of the build up area of the over wrap. The Pulse Echo indication displays a depth of 0.065 inch. Figure 66 shows the Pulse Echo signal from this region.

PART NO. STA-2A
 S/N Sample 17
 TECHNICIAN
 TEST REQ Full-wave
 TEST LOCATION C

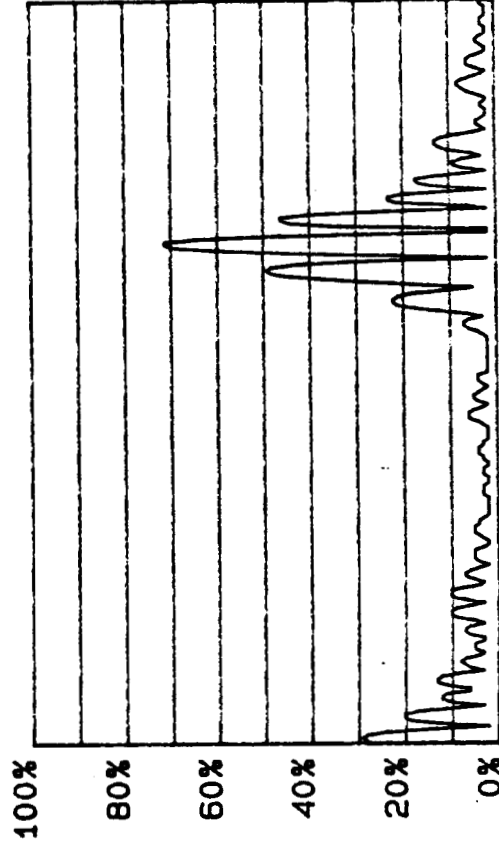
Test sample 18 was chosen for the same reason as sample 17, it contains the forward edge boundary for the delamination growth. The inspection at MSFC indicated the delamination to extend approximately 2 inches beyond the Stiffener Ring at this location. A post test visual of this part shows the delamination terminated under the Stiffener Rib. This is shown in Figure 67. The inspection at MSFC indicated the depth to be 1.00-1.15 inches. The mechanical measured depth on the sample was 1.515 inches. There is a question of the origin of this particular sample since the post test ultrasonic results and visual examination conflict with the MSFC inspection of the forward growth boundary. Figure 68 shows the inspection results after the sample was cut out. This inspection shows no ultrasonic defect indication forward of the Aft Stiffener Rib. If the sample was taken from the area of 130 degrees instead of 140 degrees the post inspection results would confirm the inspection at MSFC. Figure 69 shows the waveform recorded from the sample at location B.

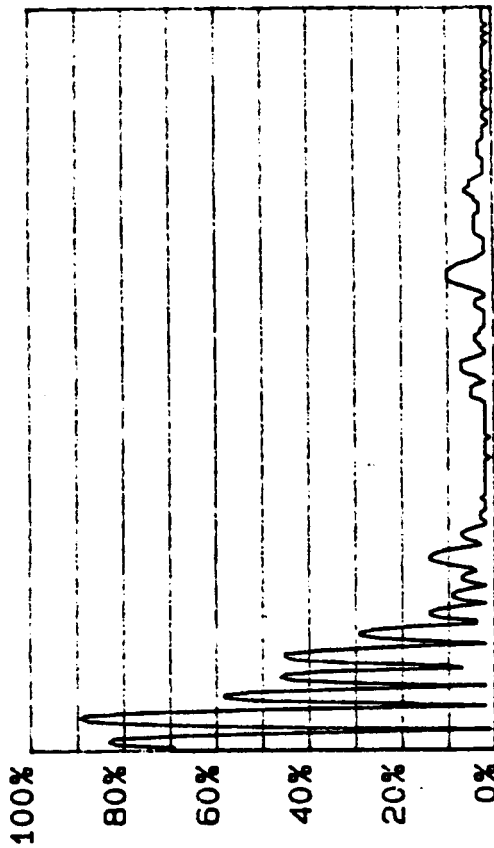
FIGURE 72.

Sample 19 was chosen because this was an AE active area generating friction type emissions. The Pulse Echo inspection at MSFC indicated this was a circumferential termination point of the major delamination. The origin and dimensions of the sample are shown in Figure 70. The reason for friction type AE are quite obvious from Figure 71. The interesting observation from this sample is that the Pulse Echo inspection from the OD showed areas A, B and C but did not show delamination F, G or H. The high porosity in the plastilock in this location blocked the detection of the delamination. Figures 72 and 73 show the waveforms recorded at the A and B locations.

PART NO. STA-2A
 S/N Sample 19
 TECHNICIAN _____
 TEST REQ Full-Wave
 TEST LOCATION A

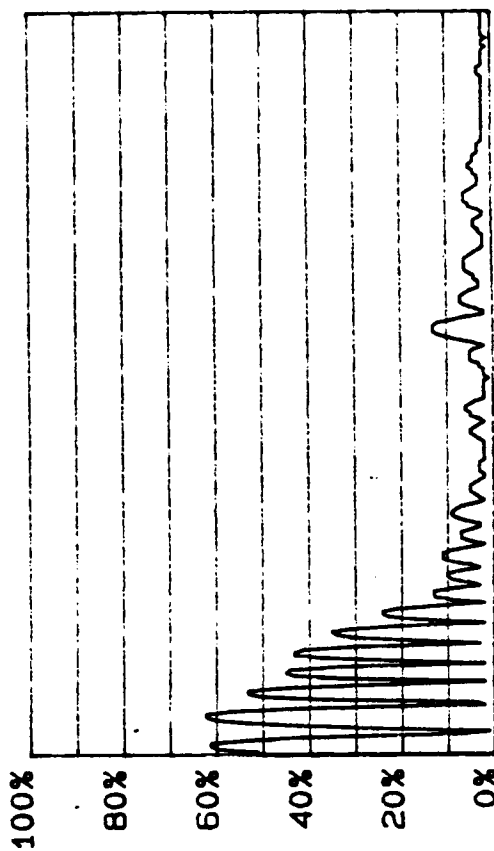
FIGURE 73.

PART NO. STA-2A
 S/N. Sample 19
 TECHNICIAN
 TEST REQ Full-Wave
 TEST LOCATION B

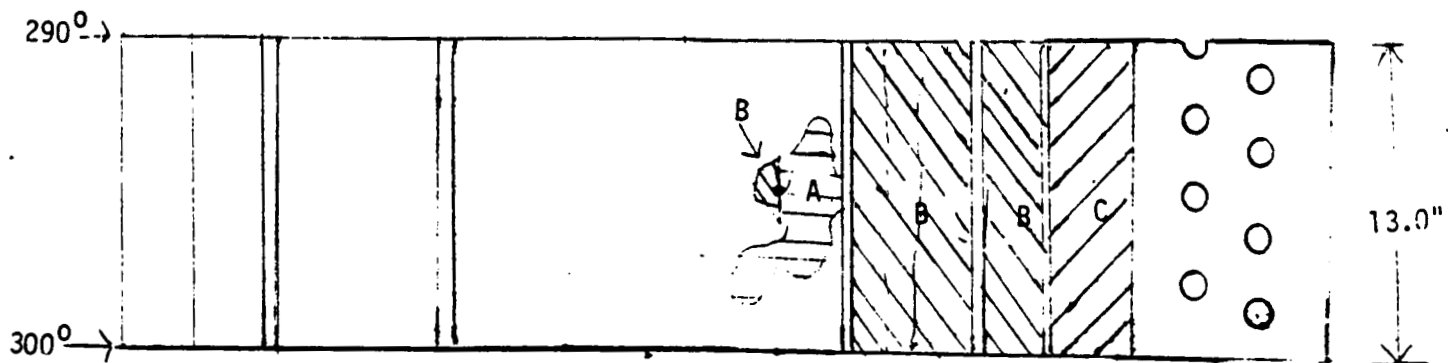
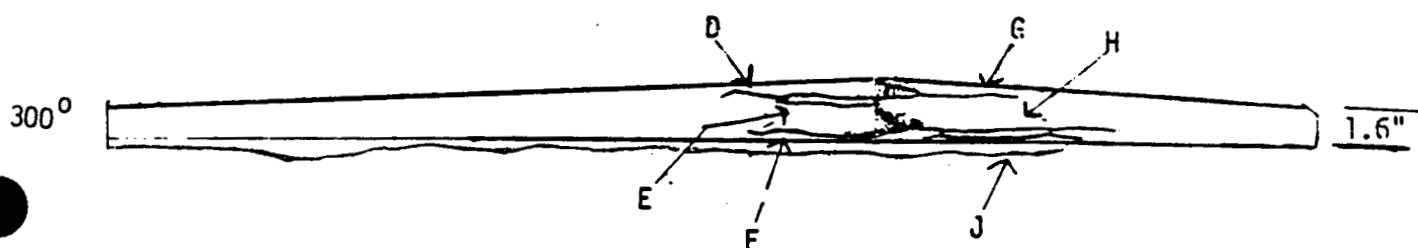
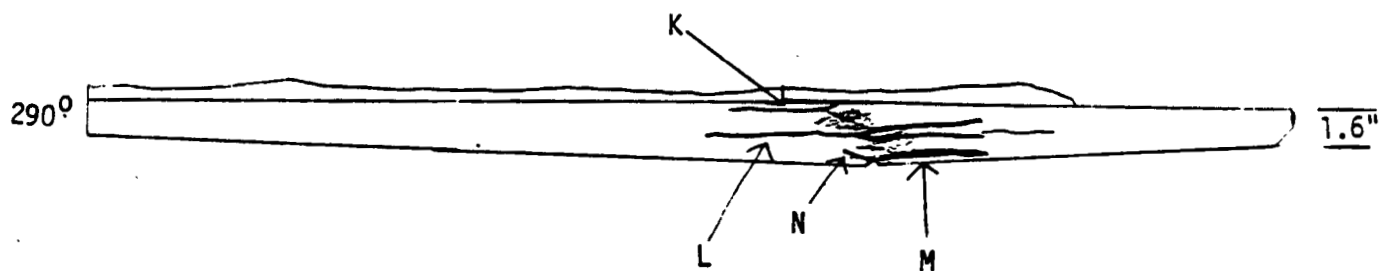
FIGURE 74. SAMPLE #20

Figure 74 shows the origin and dimensions for sample 20. This sample was chosen because it was typical of the signals we thought represented areas of high porosity in the plastilock. Figure 75 shows the porosity in the plastilock, but it also shows delaminations below. The waveform from location A shows the peaks located at 0.470 inches from OD. A mechanical measurement shows the

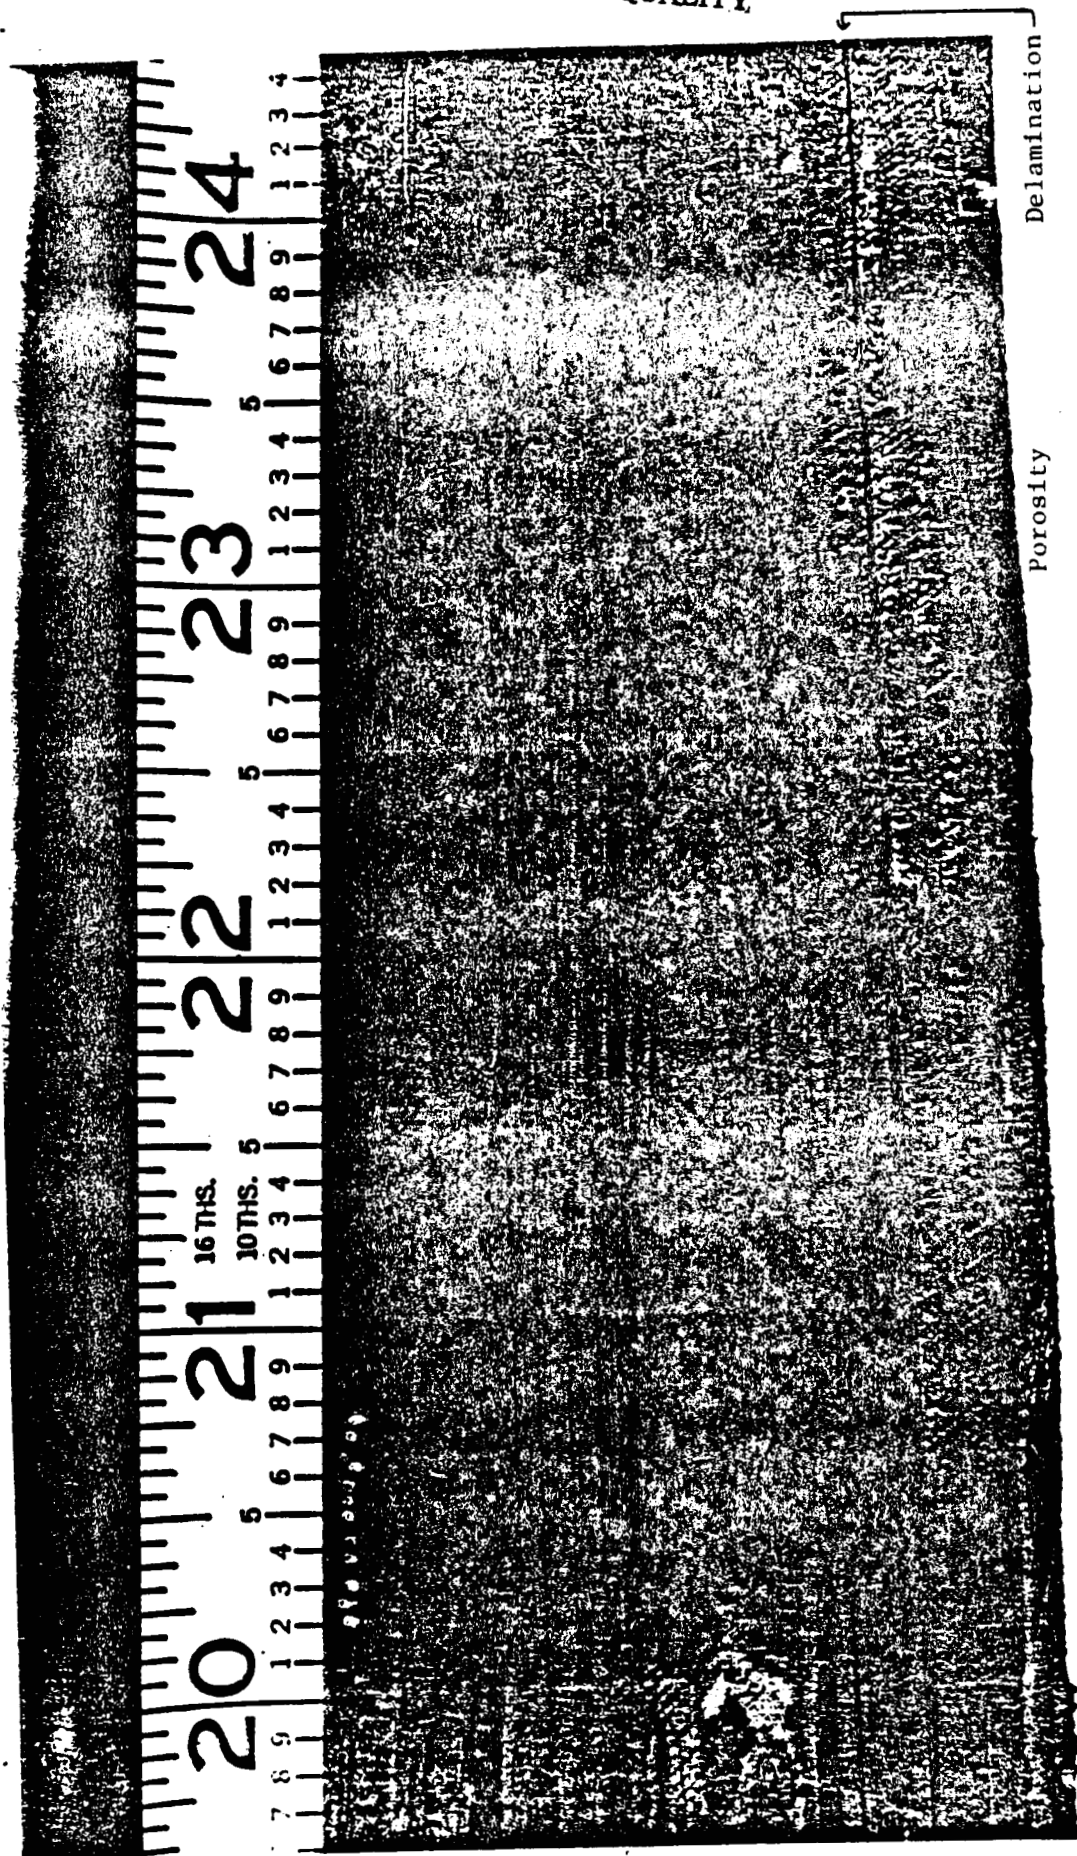
FIGURE 75. SAMPLE #20

delamination to be located 0.415 inches. Figure 76 shows a good backwall signal from a good area of this sample beyond the layer of porosity.
